GENERAL HOME INSPECTION

SUBJECT PROPERTY INFORMATION		FILE #: 2005691	
Address : 1234 Elm Street	City: Pleasantville	State: MN	Zip: 55812
Structure Age(yrs.): 25	Inspection Date: 06/25/00		
Structure Style: Two-story	Weather: Sunny	Temperature: + 76° F	
Limiting Conditions:	<input type="checkbox"/> Snow Cover	<input type="checkbox"/> Ice	<input type="checkbox"/> Rain <input type="checkbox"/> Other:

GENERAL INSPECTION
FIELD REPORT

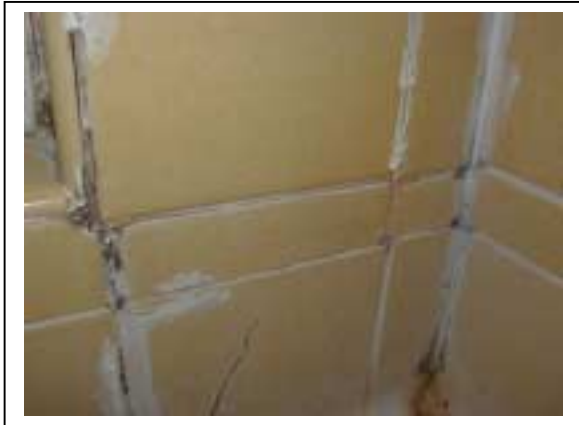
Damaged ceramic tile in master shower.

| 4. | <u>Ceramic Tile</u> – Contact a ceramic tile specialist for estimates to repair / replace the tile in the master shower. | 1,200 – 1,600 |

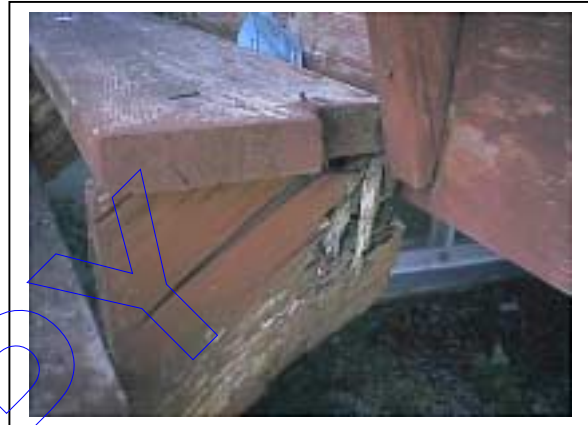
6.4	ATTACHED DECKS	N	<input type="checkbox"/> No deck present <input type="checkbox"/> Makeshift construction* <input type="checkbox"/> No flashing at ledger board*	<input type="checkbox"/> Poor plate connection* <input checked="" type="checkbox"/> Evidence of rotting* <input checked="" type="checkbox"/> Other: <i>- Rotted stringers on deck stairs. Professional repairs recommended.</i>

Rotted deck stairway stringers.

| 5. | <u>Deck Stairs</u> – The deck stairway stringers are rotted and unsafe for use. Contact a contractor for repair estimates here. | 200 - 300 |

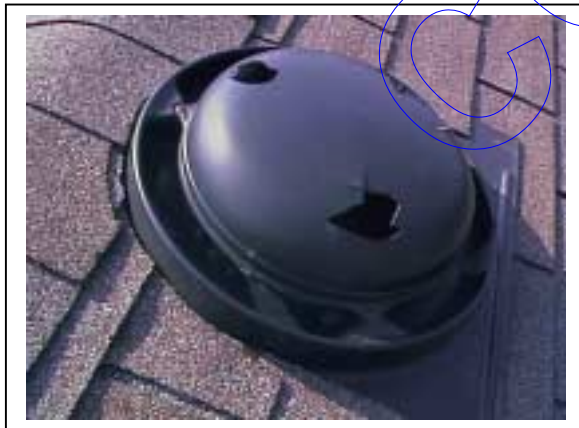
Hail damage on roof vents.

| 6. | <u>Roof Vents / Shingles</u> – Hail damage noted on shingles and roof vents. Recommend that the Seller follow up with his insurance company. | - ? - |
